INDOOR AIR QUALITY ASSESSMENT

**Lincoln Elementary School
732 Chestnut Street
Springfield, Massachusetts**

Prepared by:
Massachusetts Department of Public Health
Bureau of Environmental Health Assessment
Emergency Response/Indoor Air Quality Program
November 2003

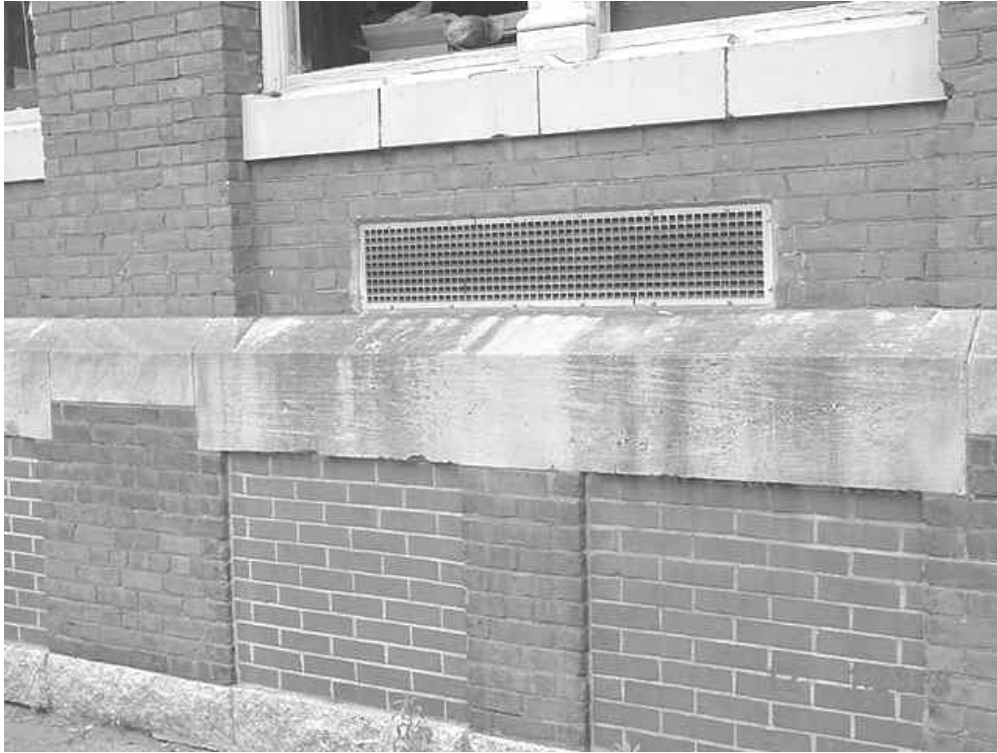
Picture 1

Fresh air in classrooms is supplied by a unit ventilator (univent) system. Univents draw air from outdoors through a fresh air intake located on the exterior walls of the building (Picture 1) and return air through an air intake located at the base of each unit ([Figure 1](#)). Fresh and return air are mixed, filtered, heated and provided to classrooms through a fresh air diffuser located in the top of the unit. The majority of univents had been deactivated during the assessment. The univent in classroom 14 was activated, however, it was not operating as designed, indicating a mechanical problem. Obstructions to airflow, such as papers and books stored on univents and items in front of univent returns were seen in a number of classrooms (Pictures 2 and 3). In order for univents to provide fresh air as designed, they must remain “on” and allowed to operate while rooms are occupied. Intakes must also remain free of obstructions.

Univent Fresh Air Intake

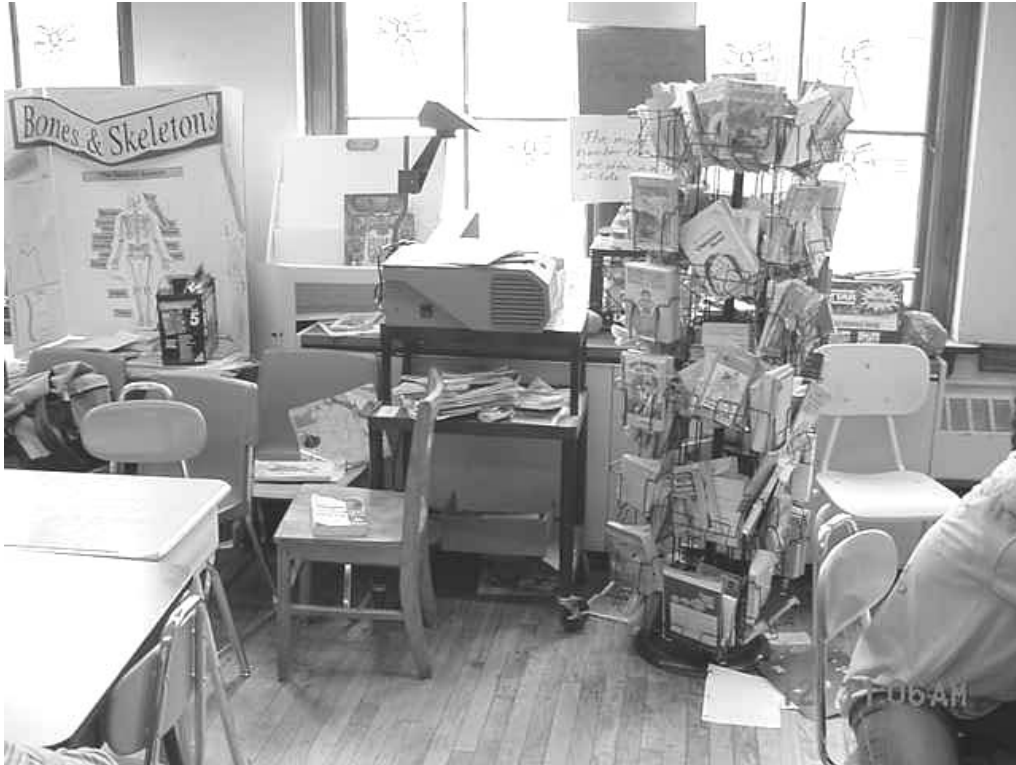
Picture 2

Classroom Items on and around Univent Obstructing Airflow

5. To maximize air exchange, operate both supply and exhaust ventilation continuously during periods of school occupancy.
6. Remove all blockages from univents to ensure adequate airflow.

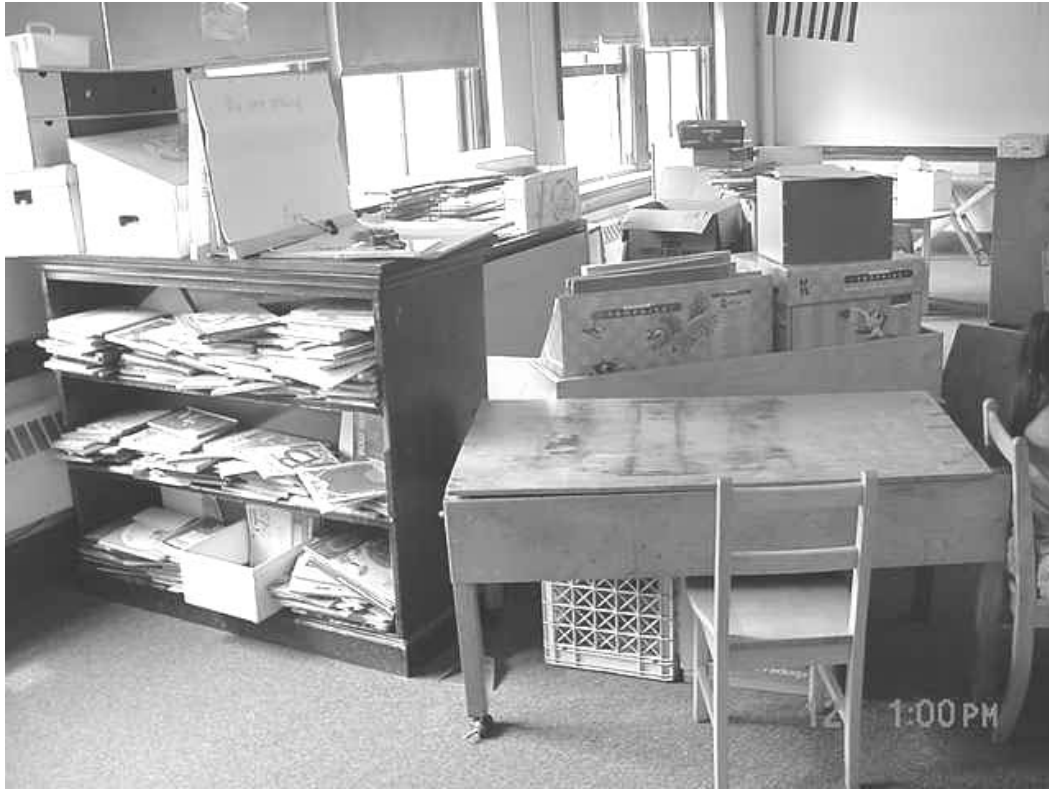
Picture 3

Classroom Furniture Configured around Univent Obstructing Airflow

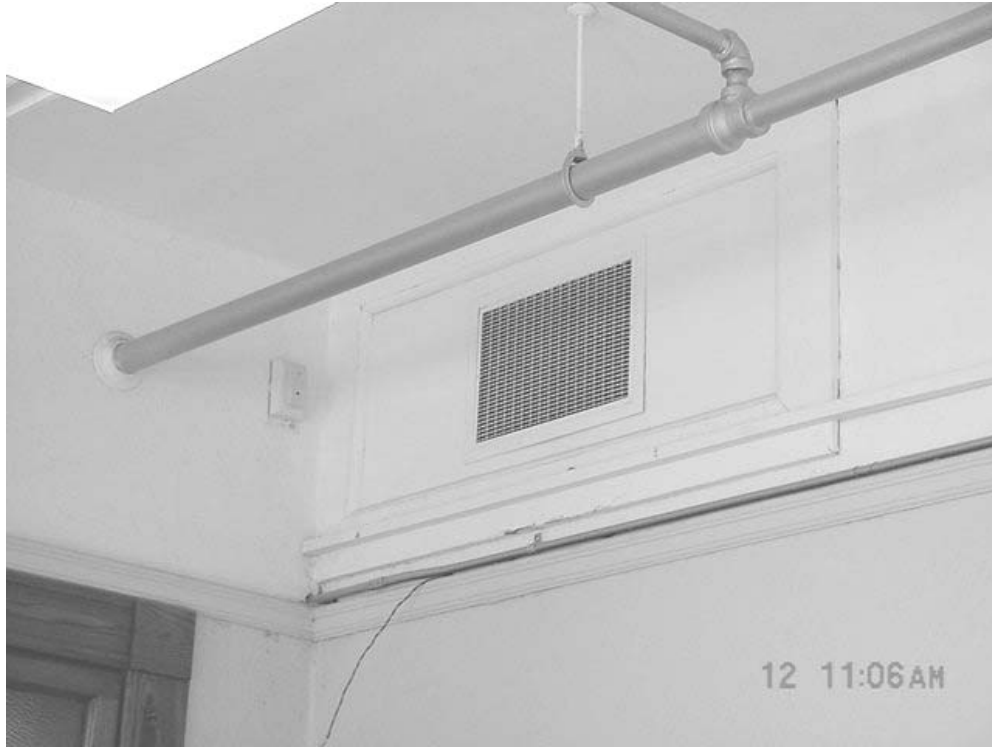
Picture 4

Exhaust ventilation in classrooms consists of wall-mounted grilles (Picture 4), powered by rooftop motors (Picture 5). The exhaust system was not functioning in the majority of areas surveyed, indicating that motors were deactivated or non-functional. BEHA staff examined exhaust motors on the roof and found four of five motors not operating. As with the univents, exhaust vents must be activated during occupancy. Without supply and exhaust ventilation, environmental pollutants can build up and lead to indoor air quality/comfort complaints.

Wall-Mounted Exhaust Grill

3. Clean accumulated dust on exhaust/return vents.
4. Restore exhaust ventilation in classrooms and restrooms to working order. Examine rooftop exhaust motors for proper function; repair and replace parts as needed.

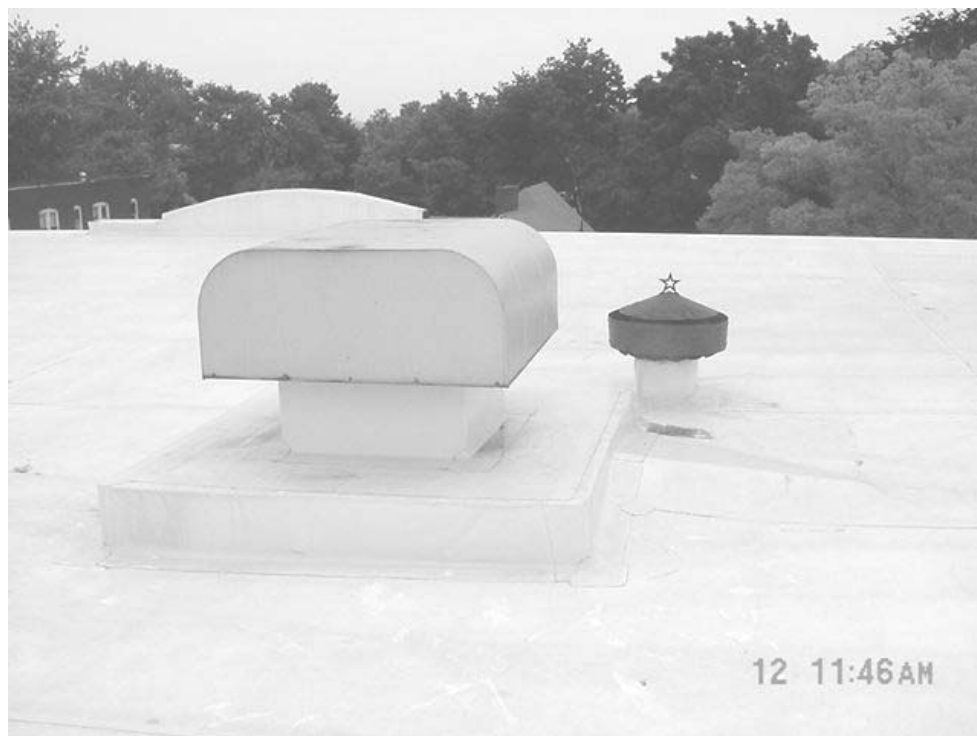
Picture 5

Rooftop Exhaust Motor

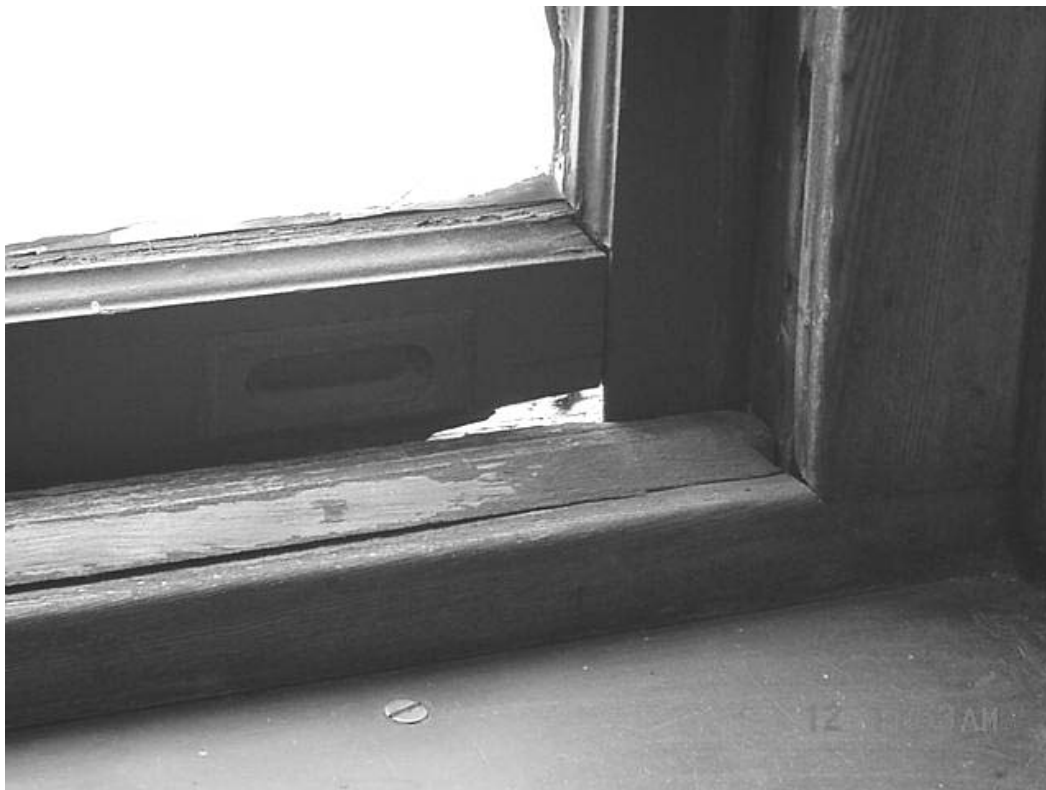
Picture 6

Damaged wooden windowsills were seen in several areas (Picture 6). A damaged wooden exterior door was observed outside of classroom 21. Damaged windowsills and/or exterior doors can allow for water penetration into the building, leading to water damage and subsequent microbial growth.

Damaged Wooden Windowsill

11. Consider repointing exterior brick.
12. Seal around utility holes on exterior of building and in classrooms with a foam insulation material.
13. Repair/replace damaged wooden windowsills and exterior doors to prevent water penetration and drafts.

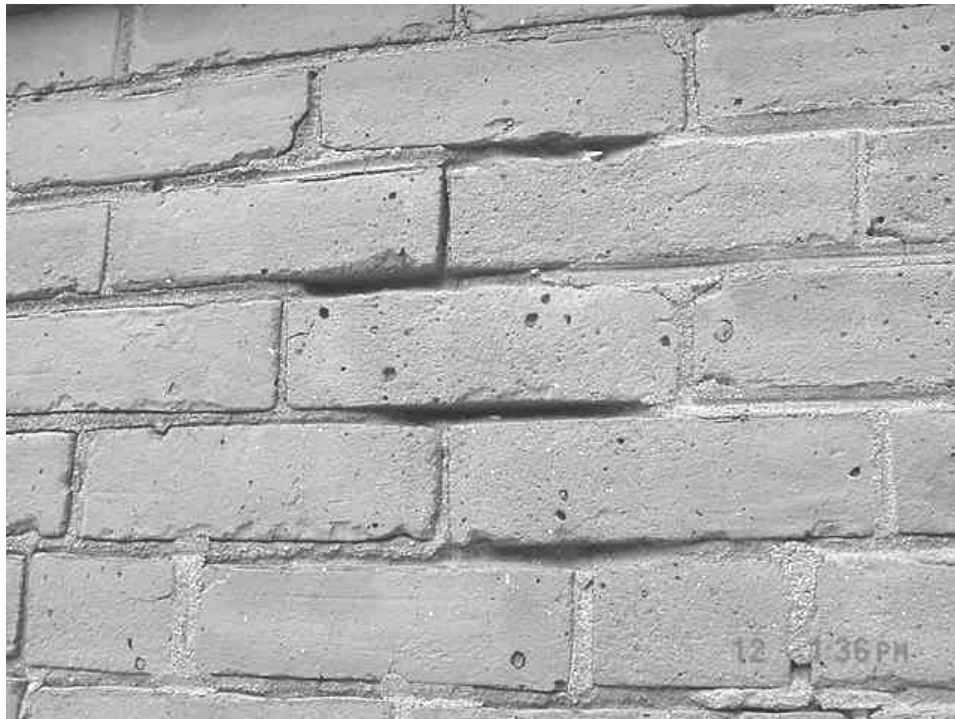
Picture 7

Missing/damaged mortar around brick and an open utility hole were observed on the exterior of the building (Pictures 7 and 8). Breaches in the building envelope can provide a means for moisture penetration into the building. Repeated water damage to porous building materials can result in microbial growth. The US Environmental Protection Agency and the American Conference of Governmental Industrial Hygienists (ACGIH) recommends that porous materials be dried with fans and heating within 24-48 hours of becoming wet (US EPA, 2001; ACGIH, 1989). If porous materials are not dried within this time frame, mold growth may occur.

Missing/Damaged Mortar

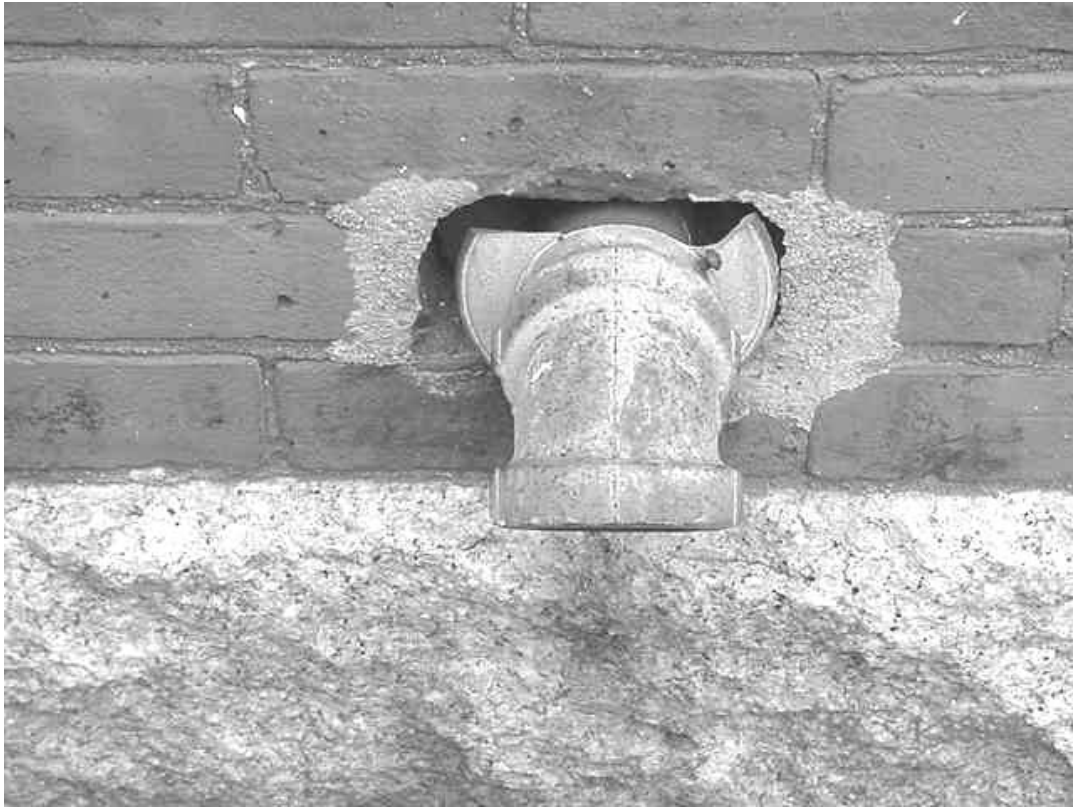
Picture 8

Open Utility Hole around Pipe

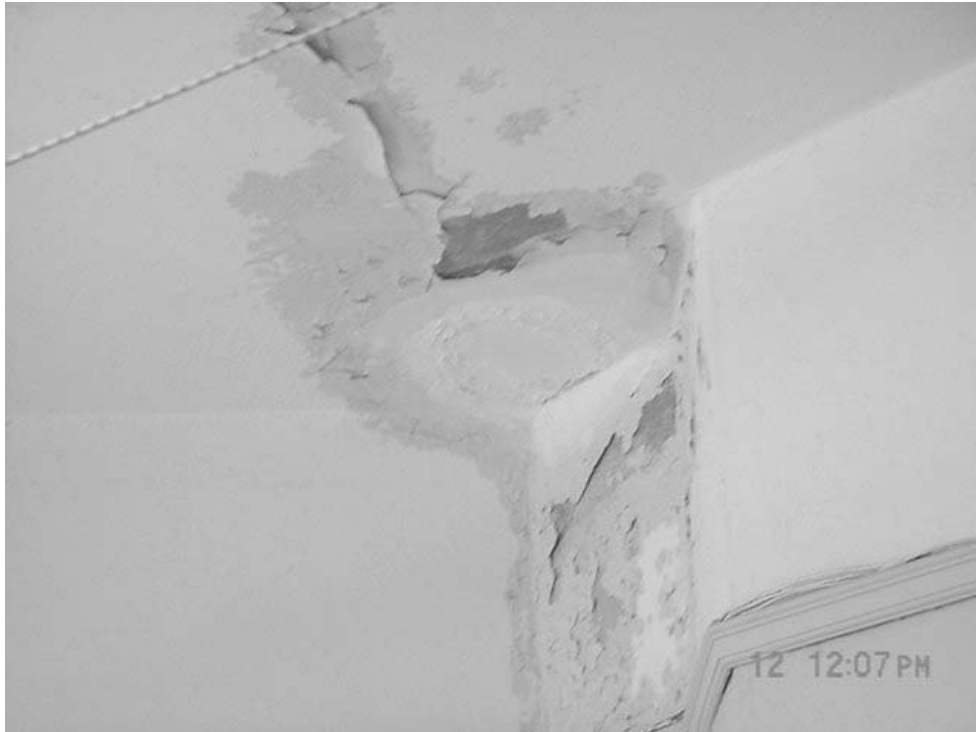
Picture 9

A number of areas had water-damaged ceiling and wall plaster, which can indicate leaks from the roof or plumbing system (Picture 9). No active roof leaks were reported or observed. In some areas, water damage appeared as a result of historic leaks. Occupants reported periodic plumbing leaks due to clogged drains in science room 6.

Water Damaged Ceiling/Wall Plaster

10. Replace/repair any water-damaged ceiling/wall plaster and building materials. Examine the area above and around these areas for mold growth. Disinfect areas of water leaks with an appropriate antimicrobial as necessary.

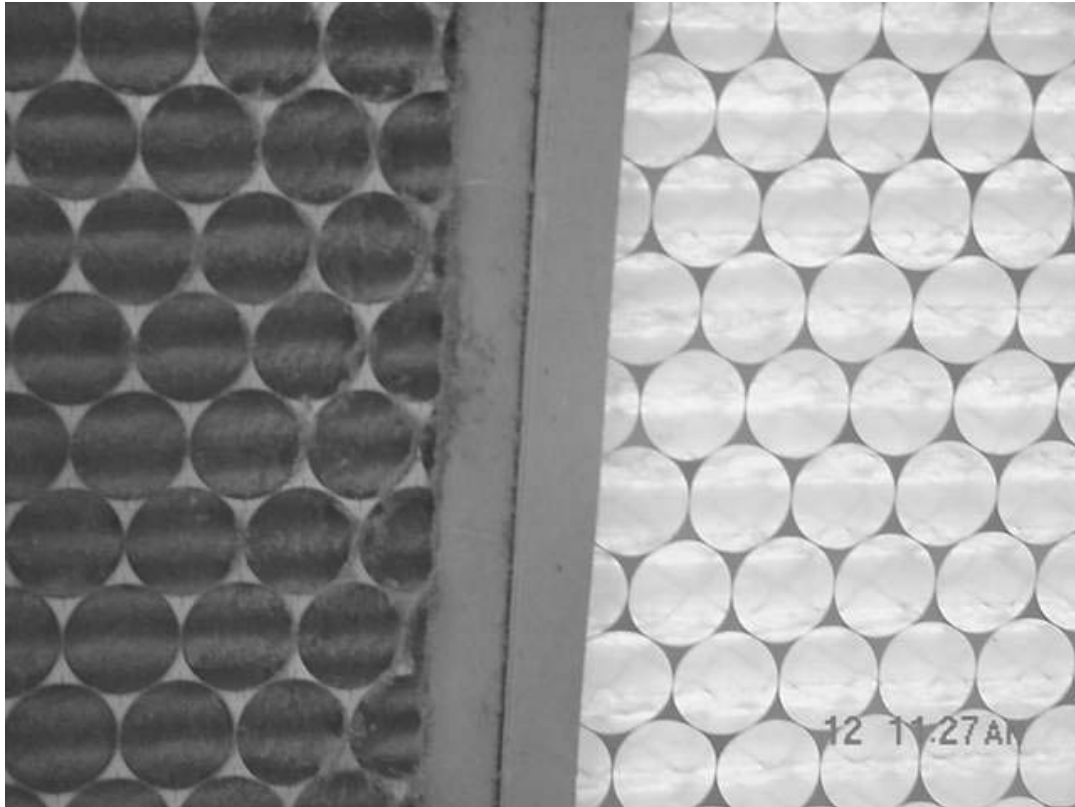
Picture 10

Univent filters were checked and found occluded with dust and debris (Picture 10). A debris-saturated filter can obstruct airflow, damage air handling equipment and serve as a reservoir of particulates that can be re-aerosolized and distributed to occupied areas via the ventilation system.

Dirty Filter from Univent in Classroom 4 Next to Clean Filter

2. Change filters for air-handling equipment as per the manufacturer's instructions or more frequently if needed. Clean out interiors of univents during each filter change.

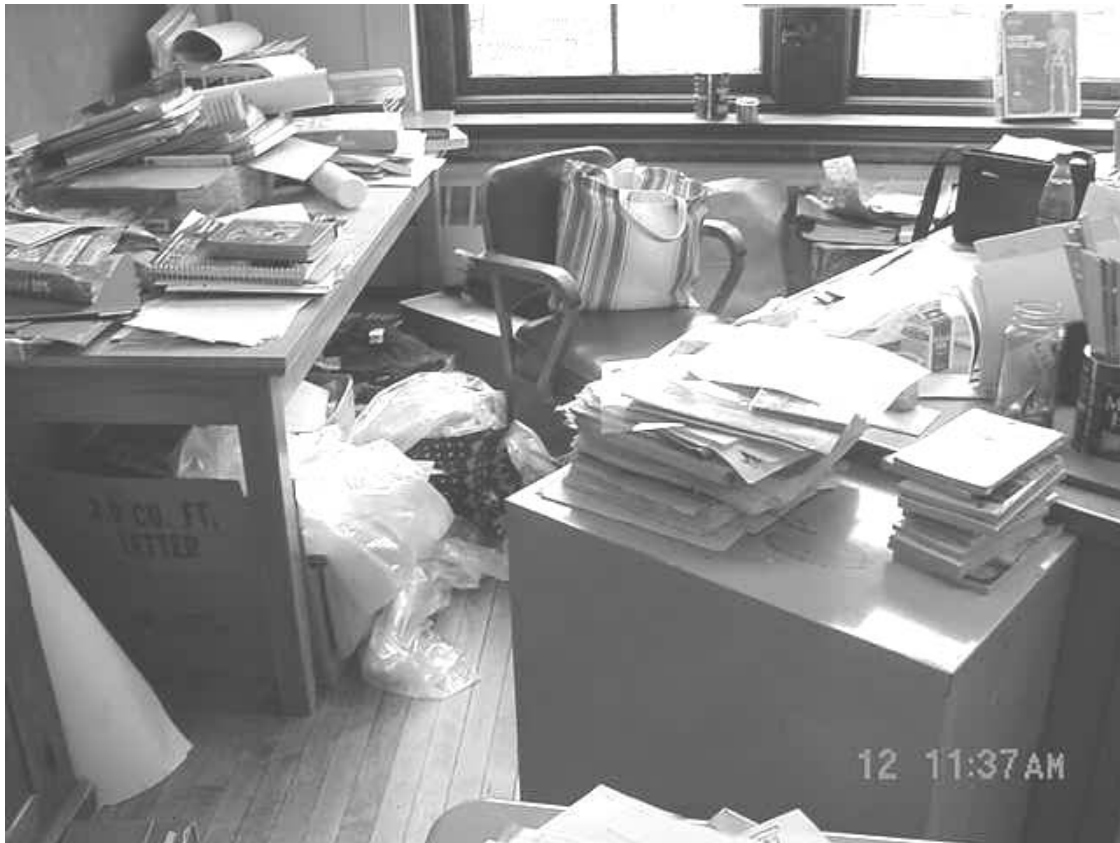
Picture 11

Exposed fiberglass pipe insulation was noted in classrooms 4 and 5. Airborne fiberglass particles can serve as a skin and respiratory irritants to sensitive individuals. Also of note was the amount of materials stored inside classrooms. In classrooms throughout the school, items were observed on windowsills, tabletops, counters, bookcases and desks (Picture 11). The large number of items stored in classrooms provides a source for dusts to accumulate and make it difficult for custodial staff to clean. As previously mentioned, dust can be irritating to eyes, nose and respiratory tract. Items should be relocated and/or be cleaned periodically to avoid excessive dust build up.

Accumulated Items in Classroom

16. Relocate or consider reducing the amount of materials stored in classrooms to allow for more thorough cleaning. Clean items regularly with a wet cloth or sponge to prevent excessive dust build-up.

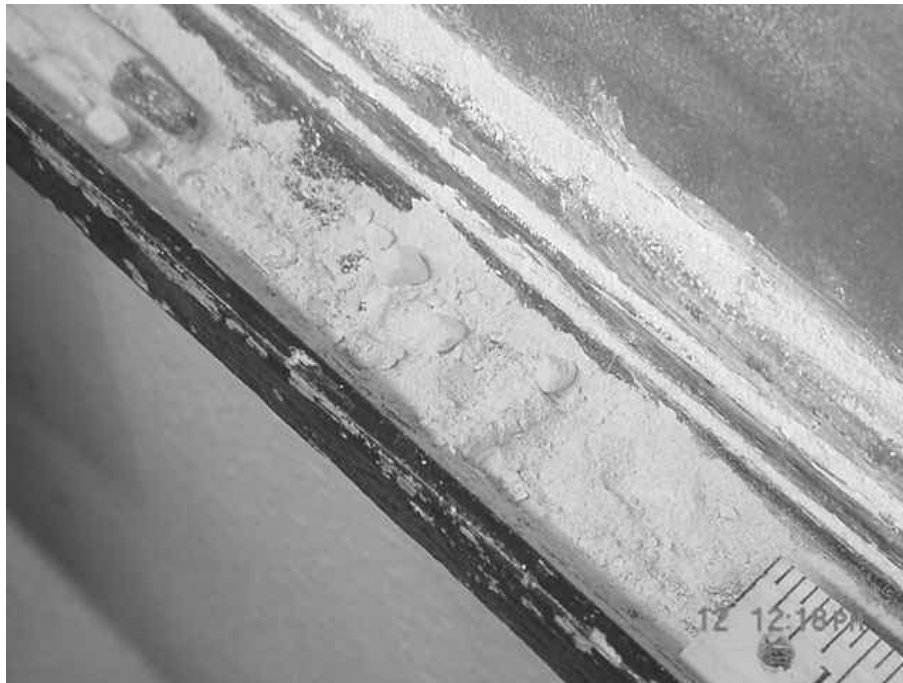
Picture 12

Accumulated chalk dust and dry erase board particulate were noted in several classrooms (Picture 12). Chalk dust and dry erase board particulates can be easily aerosolized and serve as eye and respiratory irritants. In addition, materials such as dry erase markers and dry erase board

Accumulated Chalk Dust in Classroom

17. Clean chalkboards and trays regularly to prevent the build-up of excessive chalk dust.
18. Rewrap or replace damaged fiberglass insulation in classrooms 4 and 5.

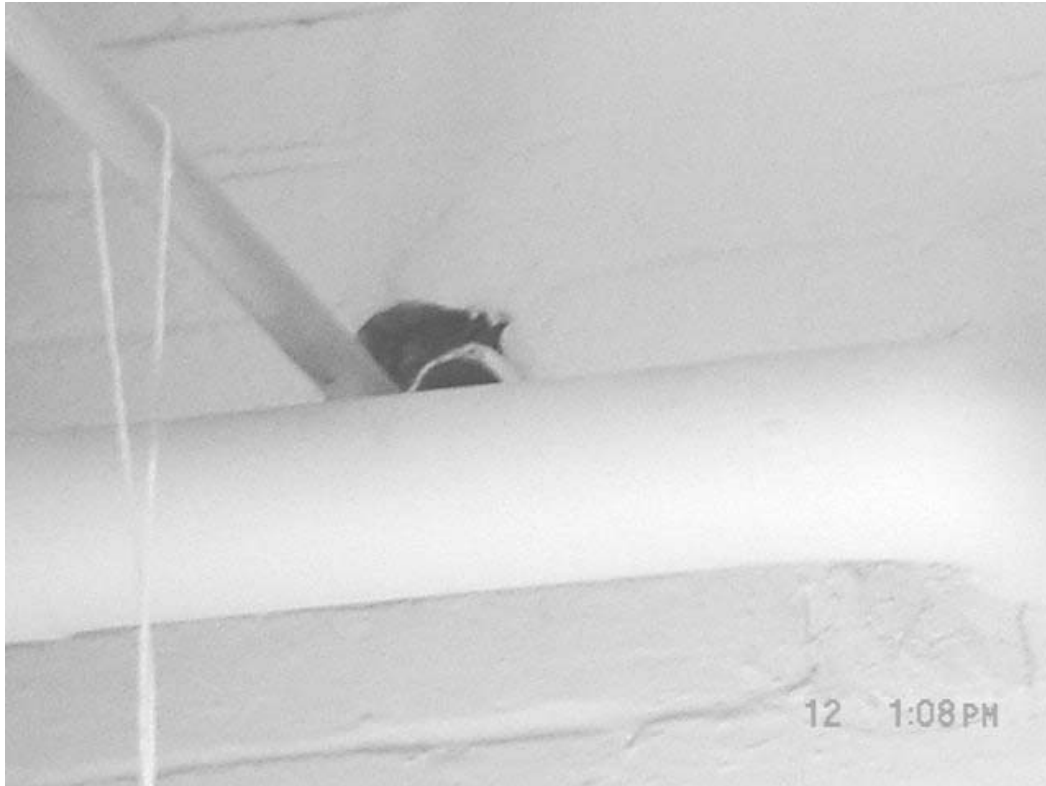
Picture 13

Lastly, open utility holes were found around pipes several rooms (Picture 13). Open utility holes can provide a pathway for the movement of drafts, dusts and particulate matter between rooms and floors.

Open Utility Hole around Pipe
